Assessment of hydrological effects for a proposed expansion of the Whenuku Rd quarry, Normanby, South Taranaki

Prepared for
The Trustees
Horizon Trust
PO Box 414
Whanganui 4541

By
Karl Browne BSc, MSc
Geosearch Limited

18 September 2020

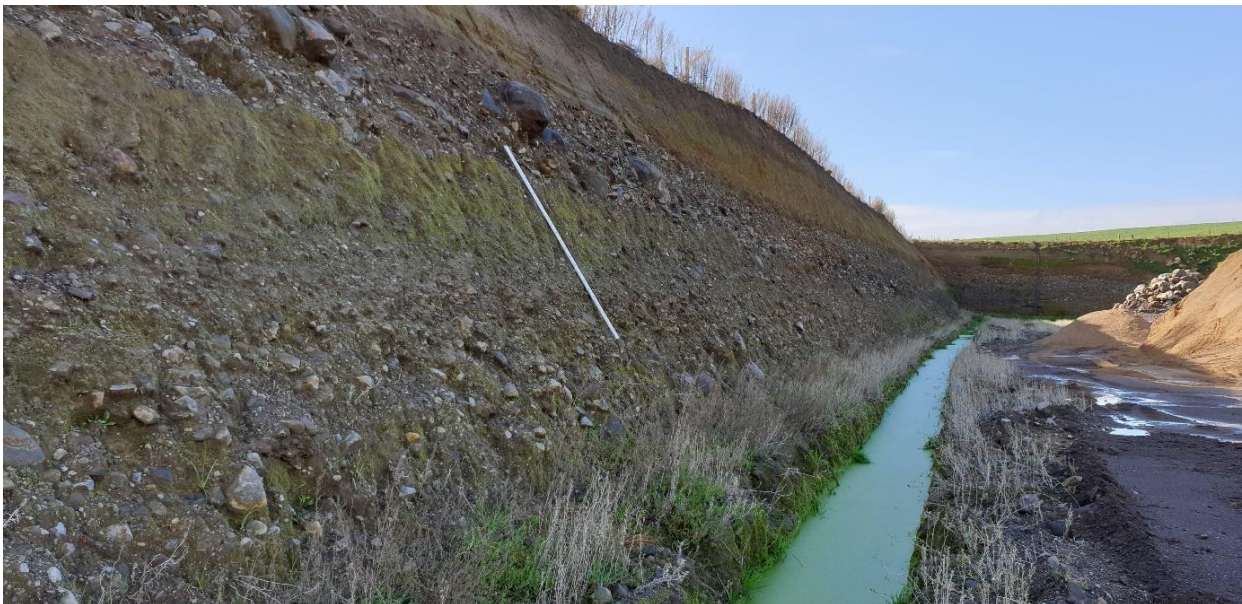
Photograph 1 Northwest face. White stick is 2.4 m long. Pit floor is just above the groundwater level exposed in the ring drain (Geosearch 15 May-19)

The quarried material lies below about 2 m of ash soil cover (Photos 1-3). The deposit is layered with laterally continuous beds of alluvium 1.5-2.5 m thick. The deposit strikes north-east and is bounded by the river. Papa mudstone lies below the alluvium (Figure 4). Quarry materials comprise andesite sands, rounded gravel and boulders in a matrix of silty sand. Sorting within layers is very poor. Materials are tightly packed with interlocking grains that give structural integrity to pit walls. The deposit contains muddy lenses (Photo 2).

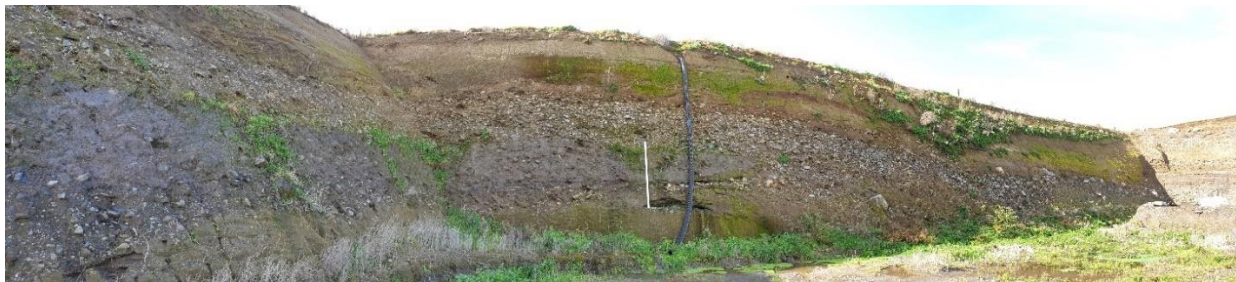
Photograph 2 Northeast face. White stick is 2.4 m long (Geosearch 15 May-19).

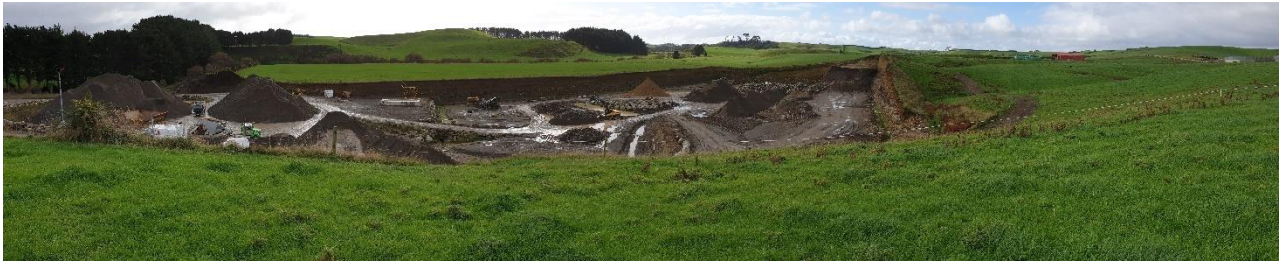
Photograph 3 Whenuku Rd quarry looking northwest with Waingongoro River beyond (Geosearch 15 May-19).

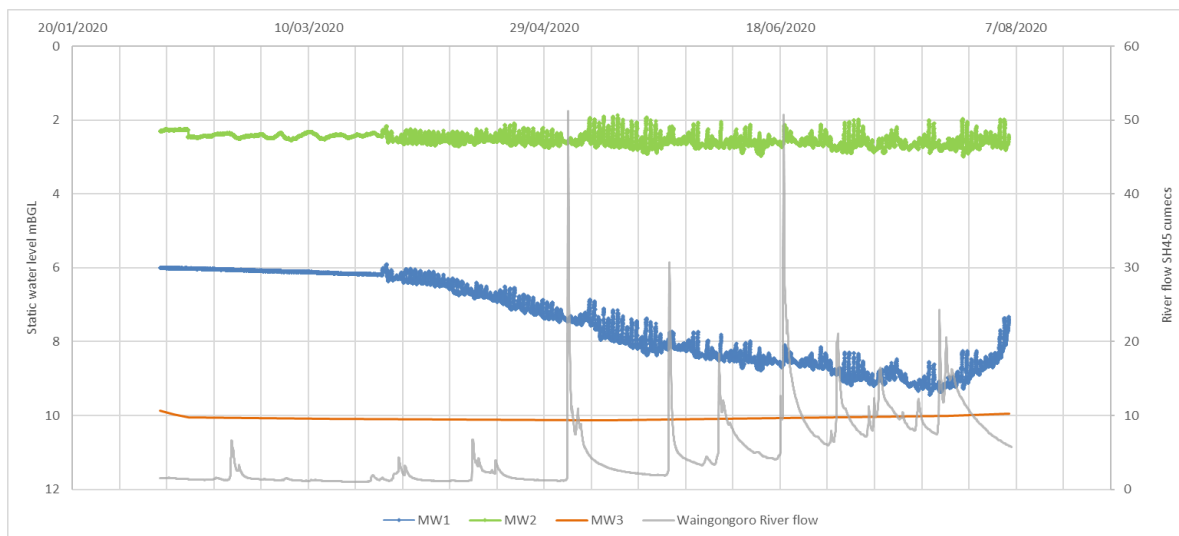
Graph 2 Groundwater levels mBGL and river flow 7 February to 5 August 2020

Graphs 1 and 2 show water levels in metres below ground level (mBGL) for the three wells compared to rainfall and river flows obtained from TRC's Glenn Rd recorder site. Graph 3 shows groundwater levels reduced to metres above sea level (mASL) and shows levels in MW1 and MW3 are elevated well above those in MW2. These elevations establish the slope of the local water table.

Overall, levels in MW1 declined from February to July 2020, followed by a sharp rise through to the end of the data period in August. MW3 showed similar but muted response. The curve was generally consistent with river flows, in that the decline occurred during low flow and the rise when river flows increased. This observation suggests MW1 has a hydraulic connection with the river. There was insufficient data to say if this was also the case in MW3. Overall, levels in MW2 showed a slight declining trend over the data period with no upswing at the end. The curve suggests there was no connection between this well and the river.

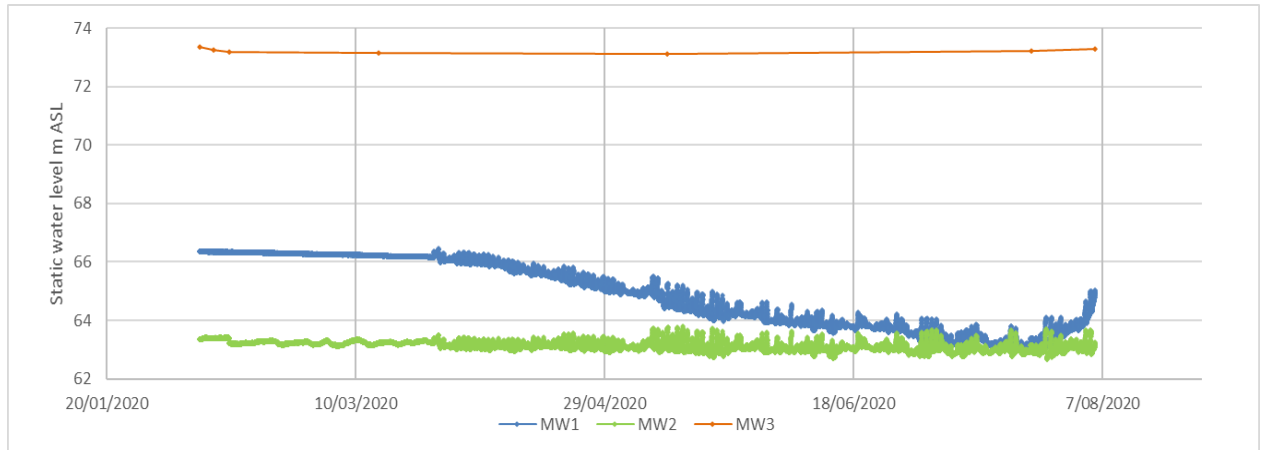
Graph 3 Reduced groundwater levels mASL 7 February to 5 August 2020

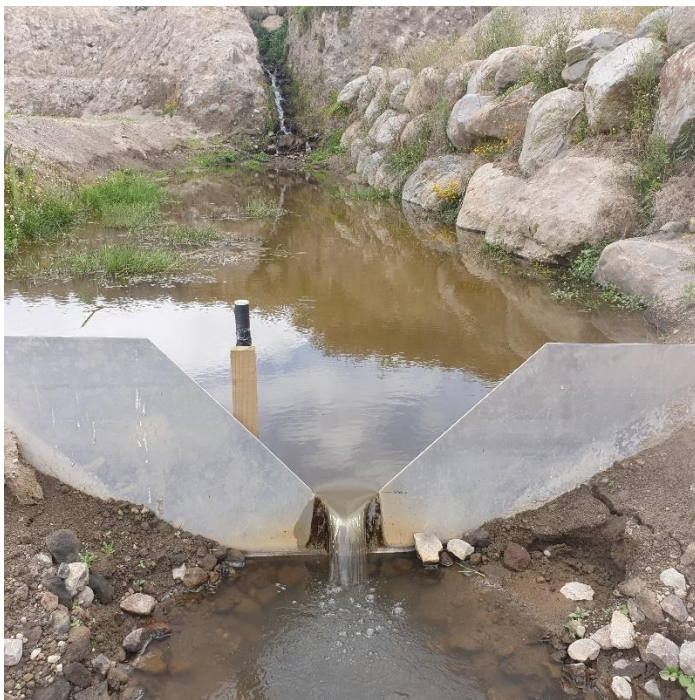
Photograph 4 Near low-flow in tributary (2 l/s) at quarry 26 Jan-20

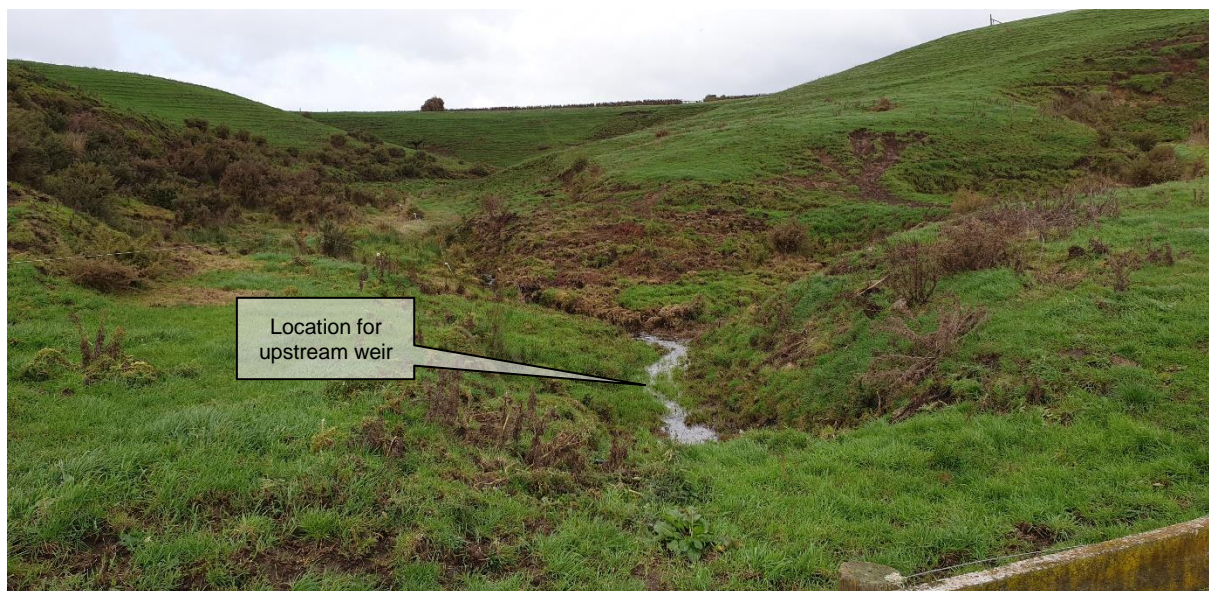
Photograph 5 General nature of the tributary above the quarry 15 May-19.

The stream has been heavily impacted by farming activities and while it does offer aquatic habitat, in its present condition is considered to have limited ecological values. Photograph 5 shows the general nature of the tributary above the quarry. Dewatering could potentially deplete flows in the tributary by drawing down the underlying groundwater surface.
